**Hurford Timbers - HM WALK MATTE SYDNEY BLUE GUM - Wet Sliptest
SN120220-7**

Slip Resistance Classification of New Pedestrian Surfaces - AS4586:2013 Appendix A

| Test Report Number: | SN120220-7 |

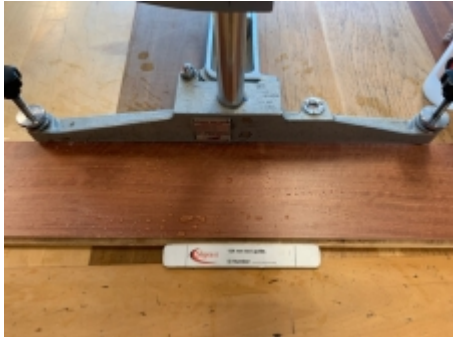
| Test Site / Surface Tested : | 136mm x 12.5mm - HM WALK MATTE - BLUE GUM |

| Sample No. | Swing 1 | Swing 2 | Swing 3 | Swing 4 | Swing 5 | Mean BPN of last 3 swings : | Surface Picture |
